River Pollution Case Study

Eastern Regional Fisheries Board

**Summary Report on pollution of the
Tolka River near Clonee, Co. Dublin**

Date of Offence: July, 2005

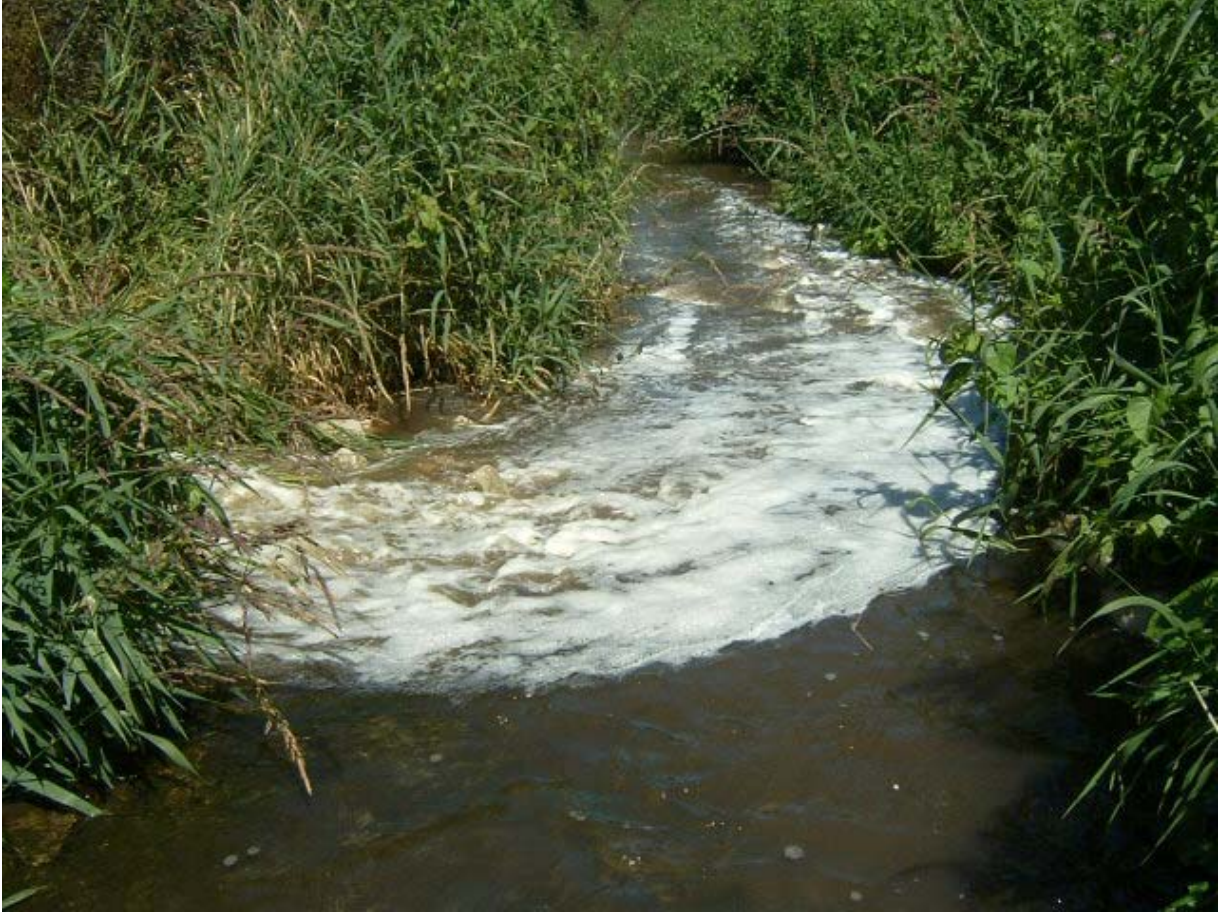
Plate 1: Voluminous discharge of noxious effluent from discharge pipe (side view).
Noxious gas in the vicinity of this discharge made it impossible to breathe

- Sample S6 was collected directly from surface water pipe SW3 when actively discharging. The effluent proved highly toxic to aquatic organisms and comprised elevated BOD, COD, pH and Ortho-P levels and a significantly elevated concentration of Ammonium (7,280 mg/l). Ammonia is generally present in natural waters, through in very small amounts. When present in natural waters in levels above 0.1mg/l N, sewage or industrial contamination may be indicated (EPA, 2001)).

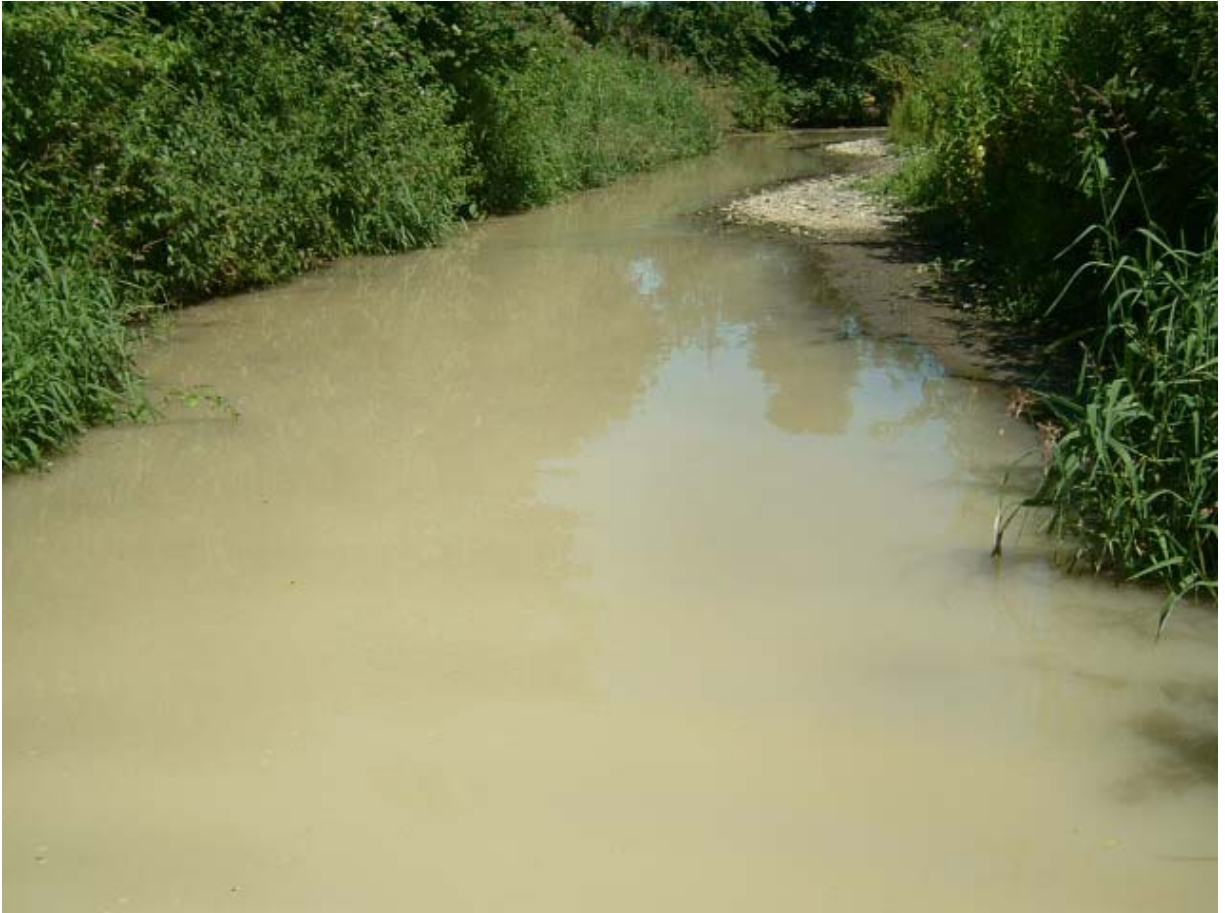
Plate 2: Discolouration of water downstream of the discharge from surface water pipe.

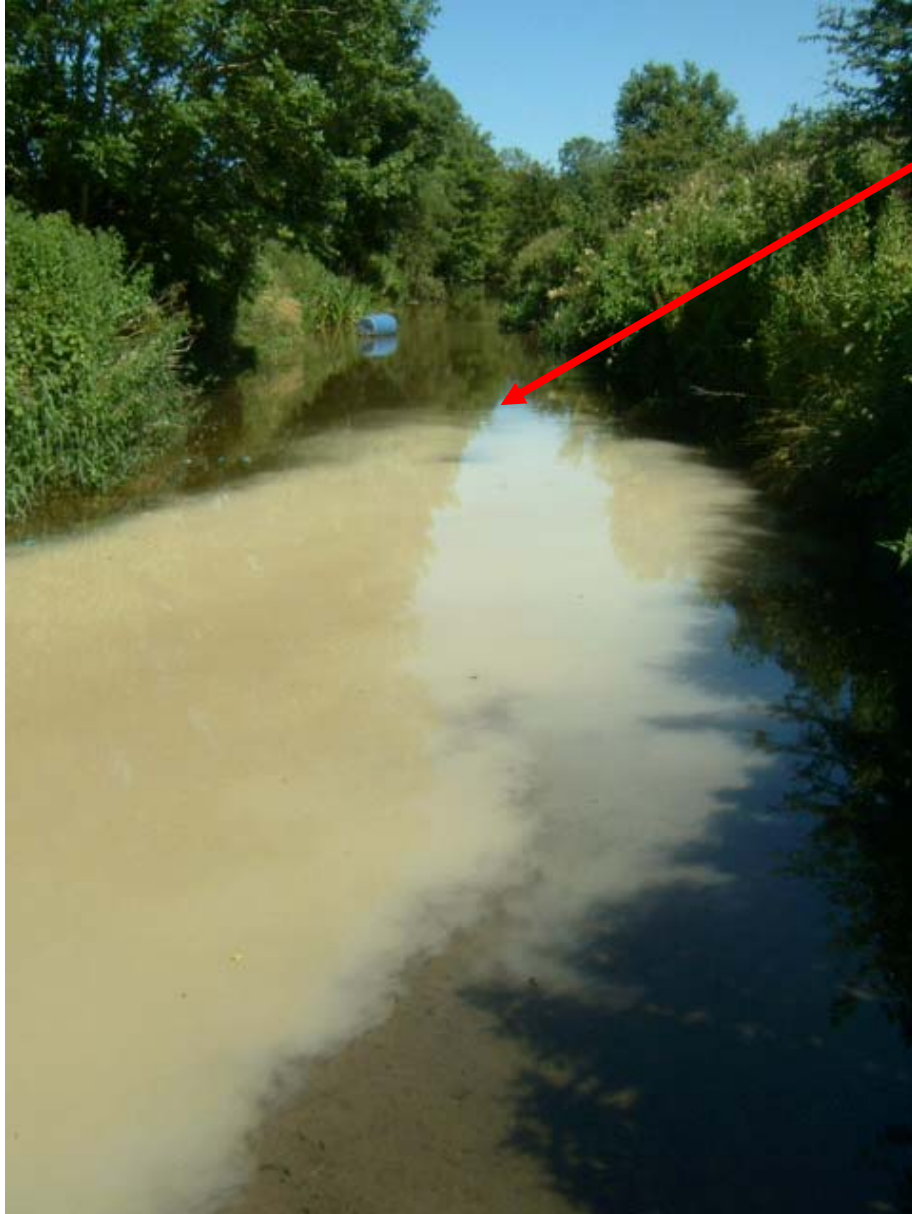
Plate 3: Discolouration of water at sampling location S7. Arrow denotes front of polluting plume as it flows downstream

- Sample 7 was collected in the Tolka River 120m downstream of the surface water pipe (i.e. the same location as sample S1) when the discharge was active. Sample

results contrast notably with S3 (upstream sample) and S1 (downstream sample prior to the discharge). This contrast represents an alteration of physico-chemical conditions within the Tolka River under the influence of the discharge. River water was highly contaminated and displayed breaches of limits for BOD, COD, pH, Suspended Solids, and Total Ammonium as stated under S.I. No. 293/1988: European Communities (Quality of Salmonid Waters) Regulations 1988. Most notable of these breaches was the level of Total Ammonium - 306 times the upper limit for salmonid waters at time of sampling. Un-ionised ammonia ($\text{NH}_3\text{-N}$) and ionised ammonia ($\text{NH}_4^+\text{-N}$) represent two forms of reduced inorganic nitrogen which exist in equilibrium depending upon the pH and temperature of the waters in which they are found. Of the two, the free ammonia form is considerably more toxic to organisms such as fish and, therefore, we pay considerable attention to the relative concentration of this particular contaminant. In the Tolka River at S7 a Total Ammonium concentration in water of 306mg/l at pH 10.05 and a temperature of 25°C would have resulted in an un-ionised ammonia concentration of 264.5mg/l. This concentration is highly toxic to freshwater aquatic organisms including all fish and most invertebrate species and represents a level approximately 13,000 times that specified as the upper limit for salmonid waters to be conformed with by 95% of samples over a 12 month period in S.I. No. 293/1988: European Communities (Quality of Salmonid Waters) Regulations 1988.

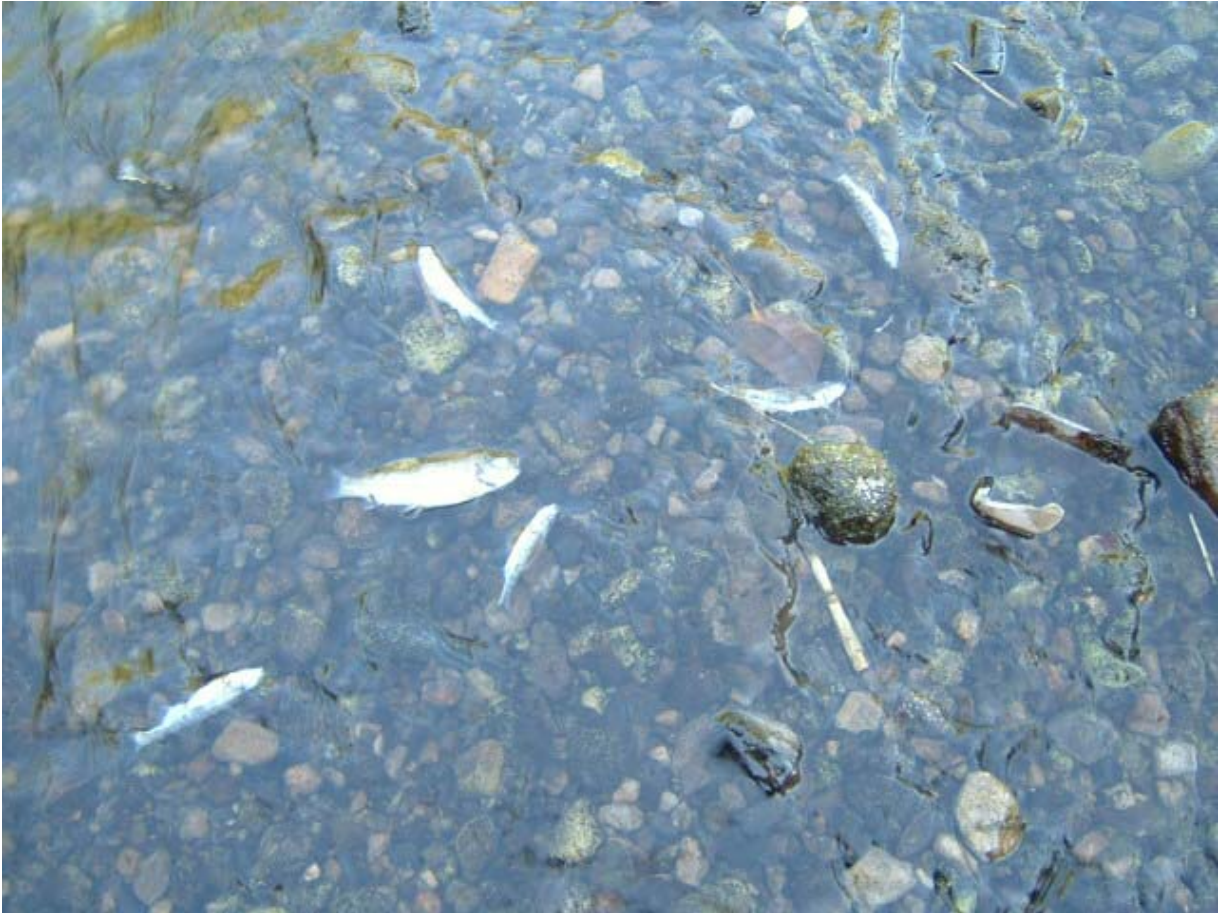
Plate 4: Dead trout downstream of surface water discharge pipe SW3. 1000's of trout were found dead in this area

ERFB FEO's visited the plant from which the pipe was discharging immediately and explained the urgent situation to senior staff. FEO's insisted that a guarantee be given that no further effluent would enter the channel from the plant. Senior staff gave this guarantee. Subsequent inspection of the Tolka River downstream of the surface water discharge pipe revealed a massive fish kill (1000's of dead fish) in addition to an apparent wipe out of most macroinvertebrate life from the discharge point downstream for a substantial distance. A subsequent electrofishing survey carried out by ERFB staff revealed 100% mortality of all salmonid fish species for a distance of approximately 7km downstream of the discharge point.

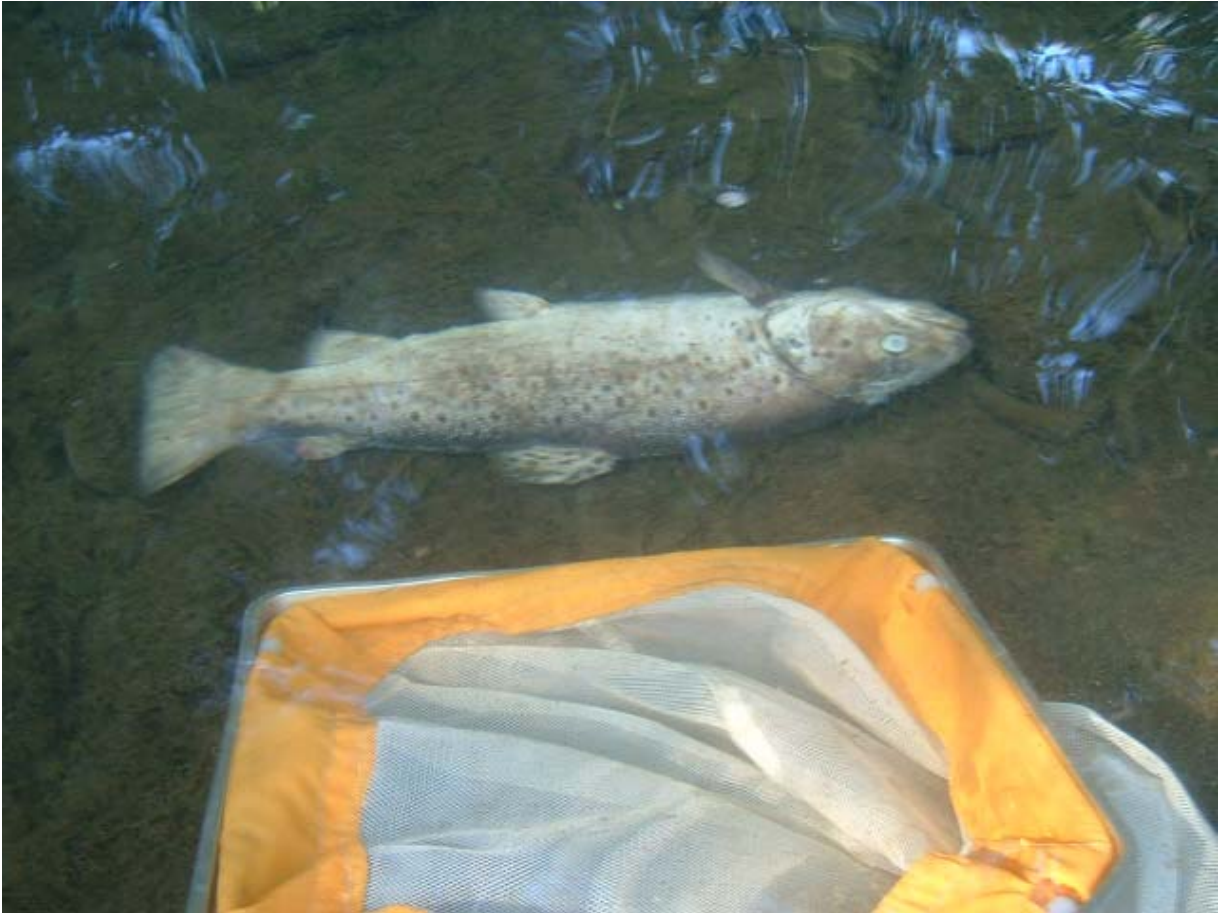
Plate 5: Dead adult trout downstream of surface water discharge pipe SW3. 100's of trout were found dead in this area

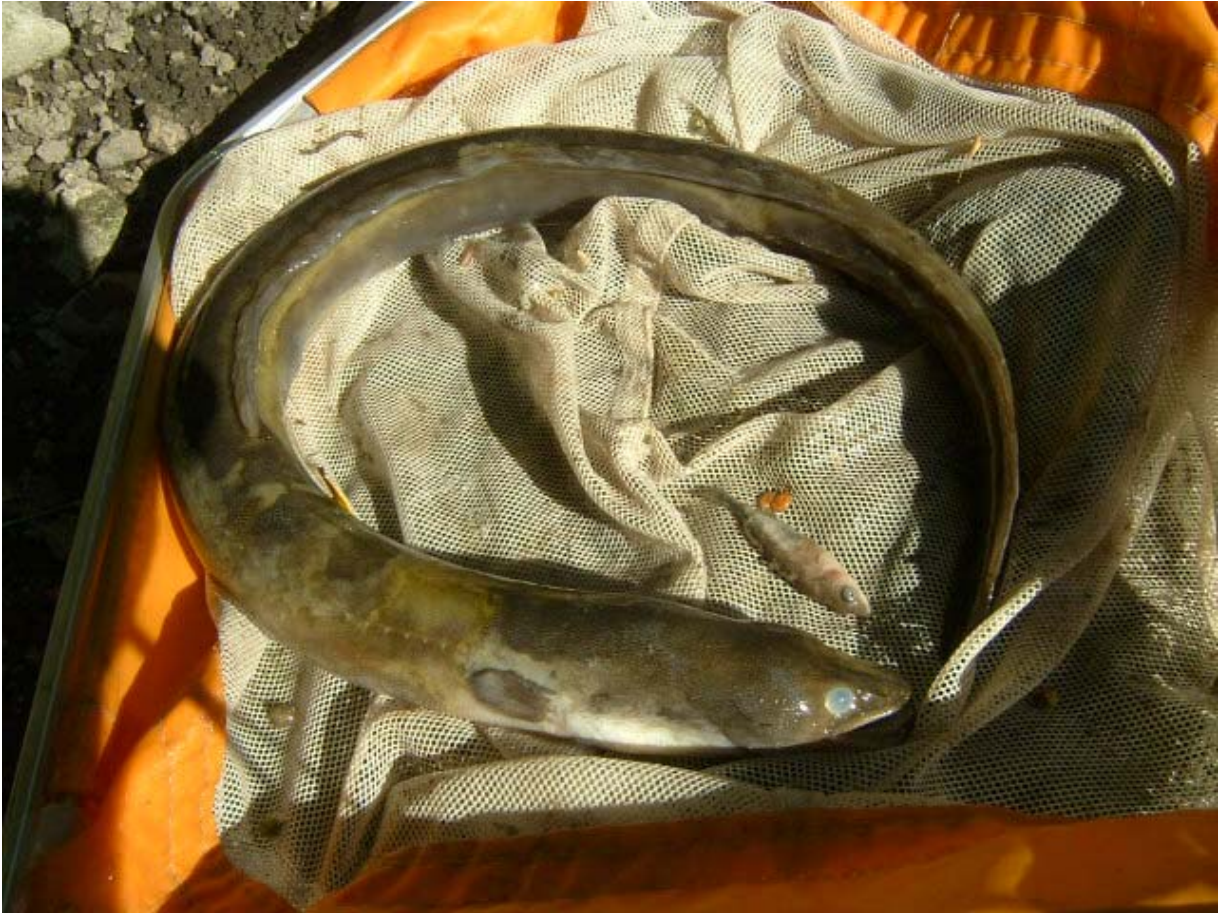
Plate 6: Dead eel and stickleback downstream of surface water discharge pipe. 1000's of stickleback, 100's of minnow, 10's of stoneloach and eels were found dead in this area
